**I/O Bus Edge Connector**  
(as viewed at top of socket)

**Physical Layout  
Unit #1**

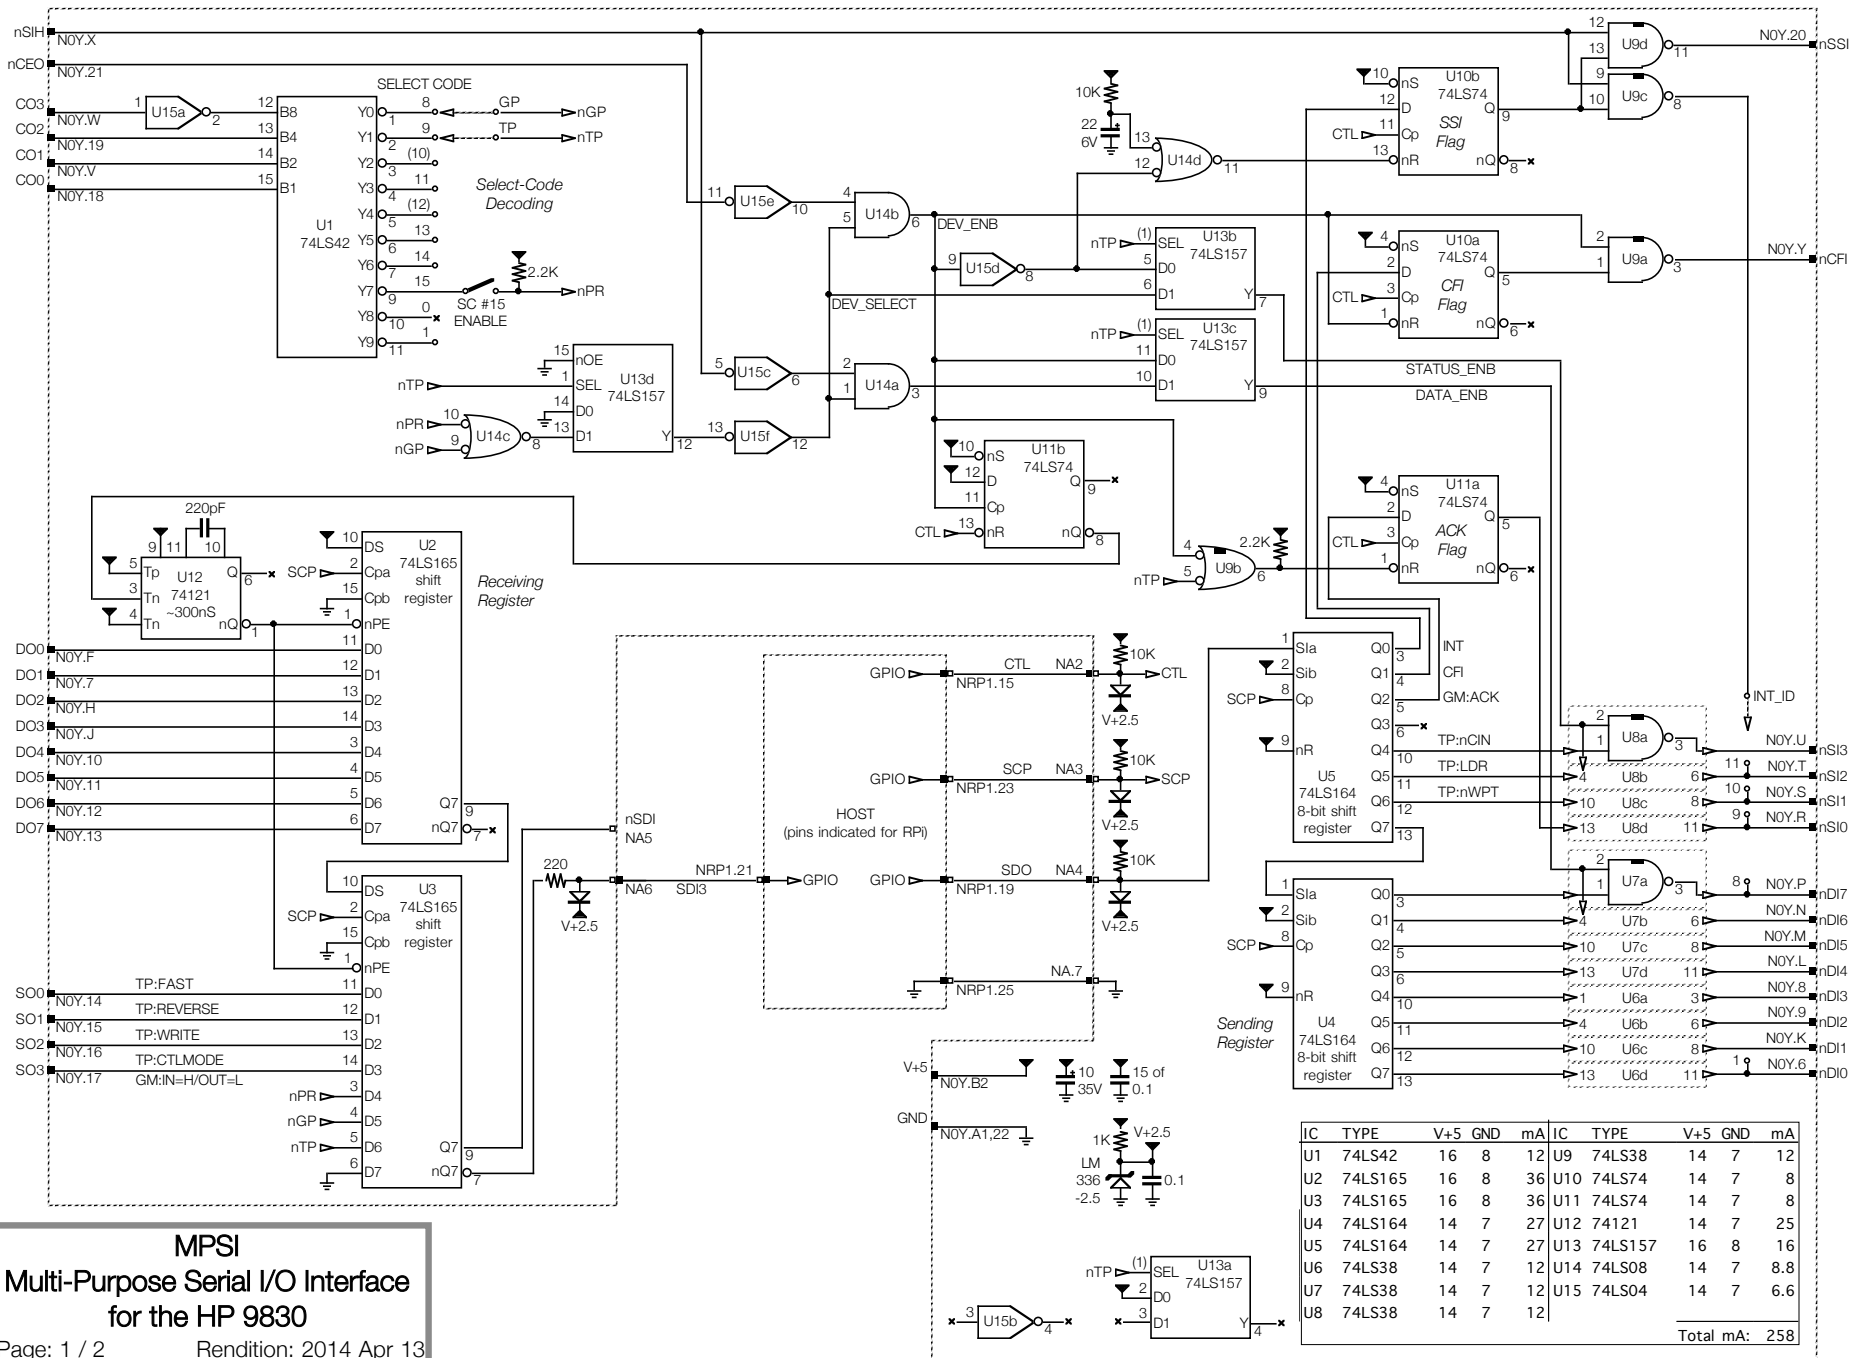
NOY			
GND	1	A	<
V+5	2	B	<
⌈0	3	C	nEDT
MCK	4	D	-
nWFM	5	E	SCK
nDI0	6	F	DO0
DO1	7	H	DO2
nDI3	8	J	DO3
nDI2	9	K	nDI1
DO4	10	L	nDI4
DO5	11	M	nDI5
DO6	12	N	nDI6
DO7	13	P	nDI7
SO0	14	R	nSI0
SO1	15	S	nSI1
SO2	16	T	nSI2
SO3	17	U	nSI3
CO0	18	V	CO1
CO2	19	W	CO3
nSSI	20	X	nSIH
nCEOb	21	Y	nCFI
GND	22	Z	nKSTOP
